LANDSLIDES AND RELATED FEATURES

OF THE NORMANDY LAKE, TENN. QUADRANGLE

by
ROGER E. THOMAS
1982

U.S. Geological Survey
Open File Map 82-750 (D-15)

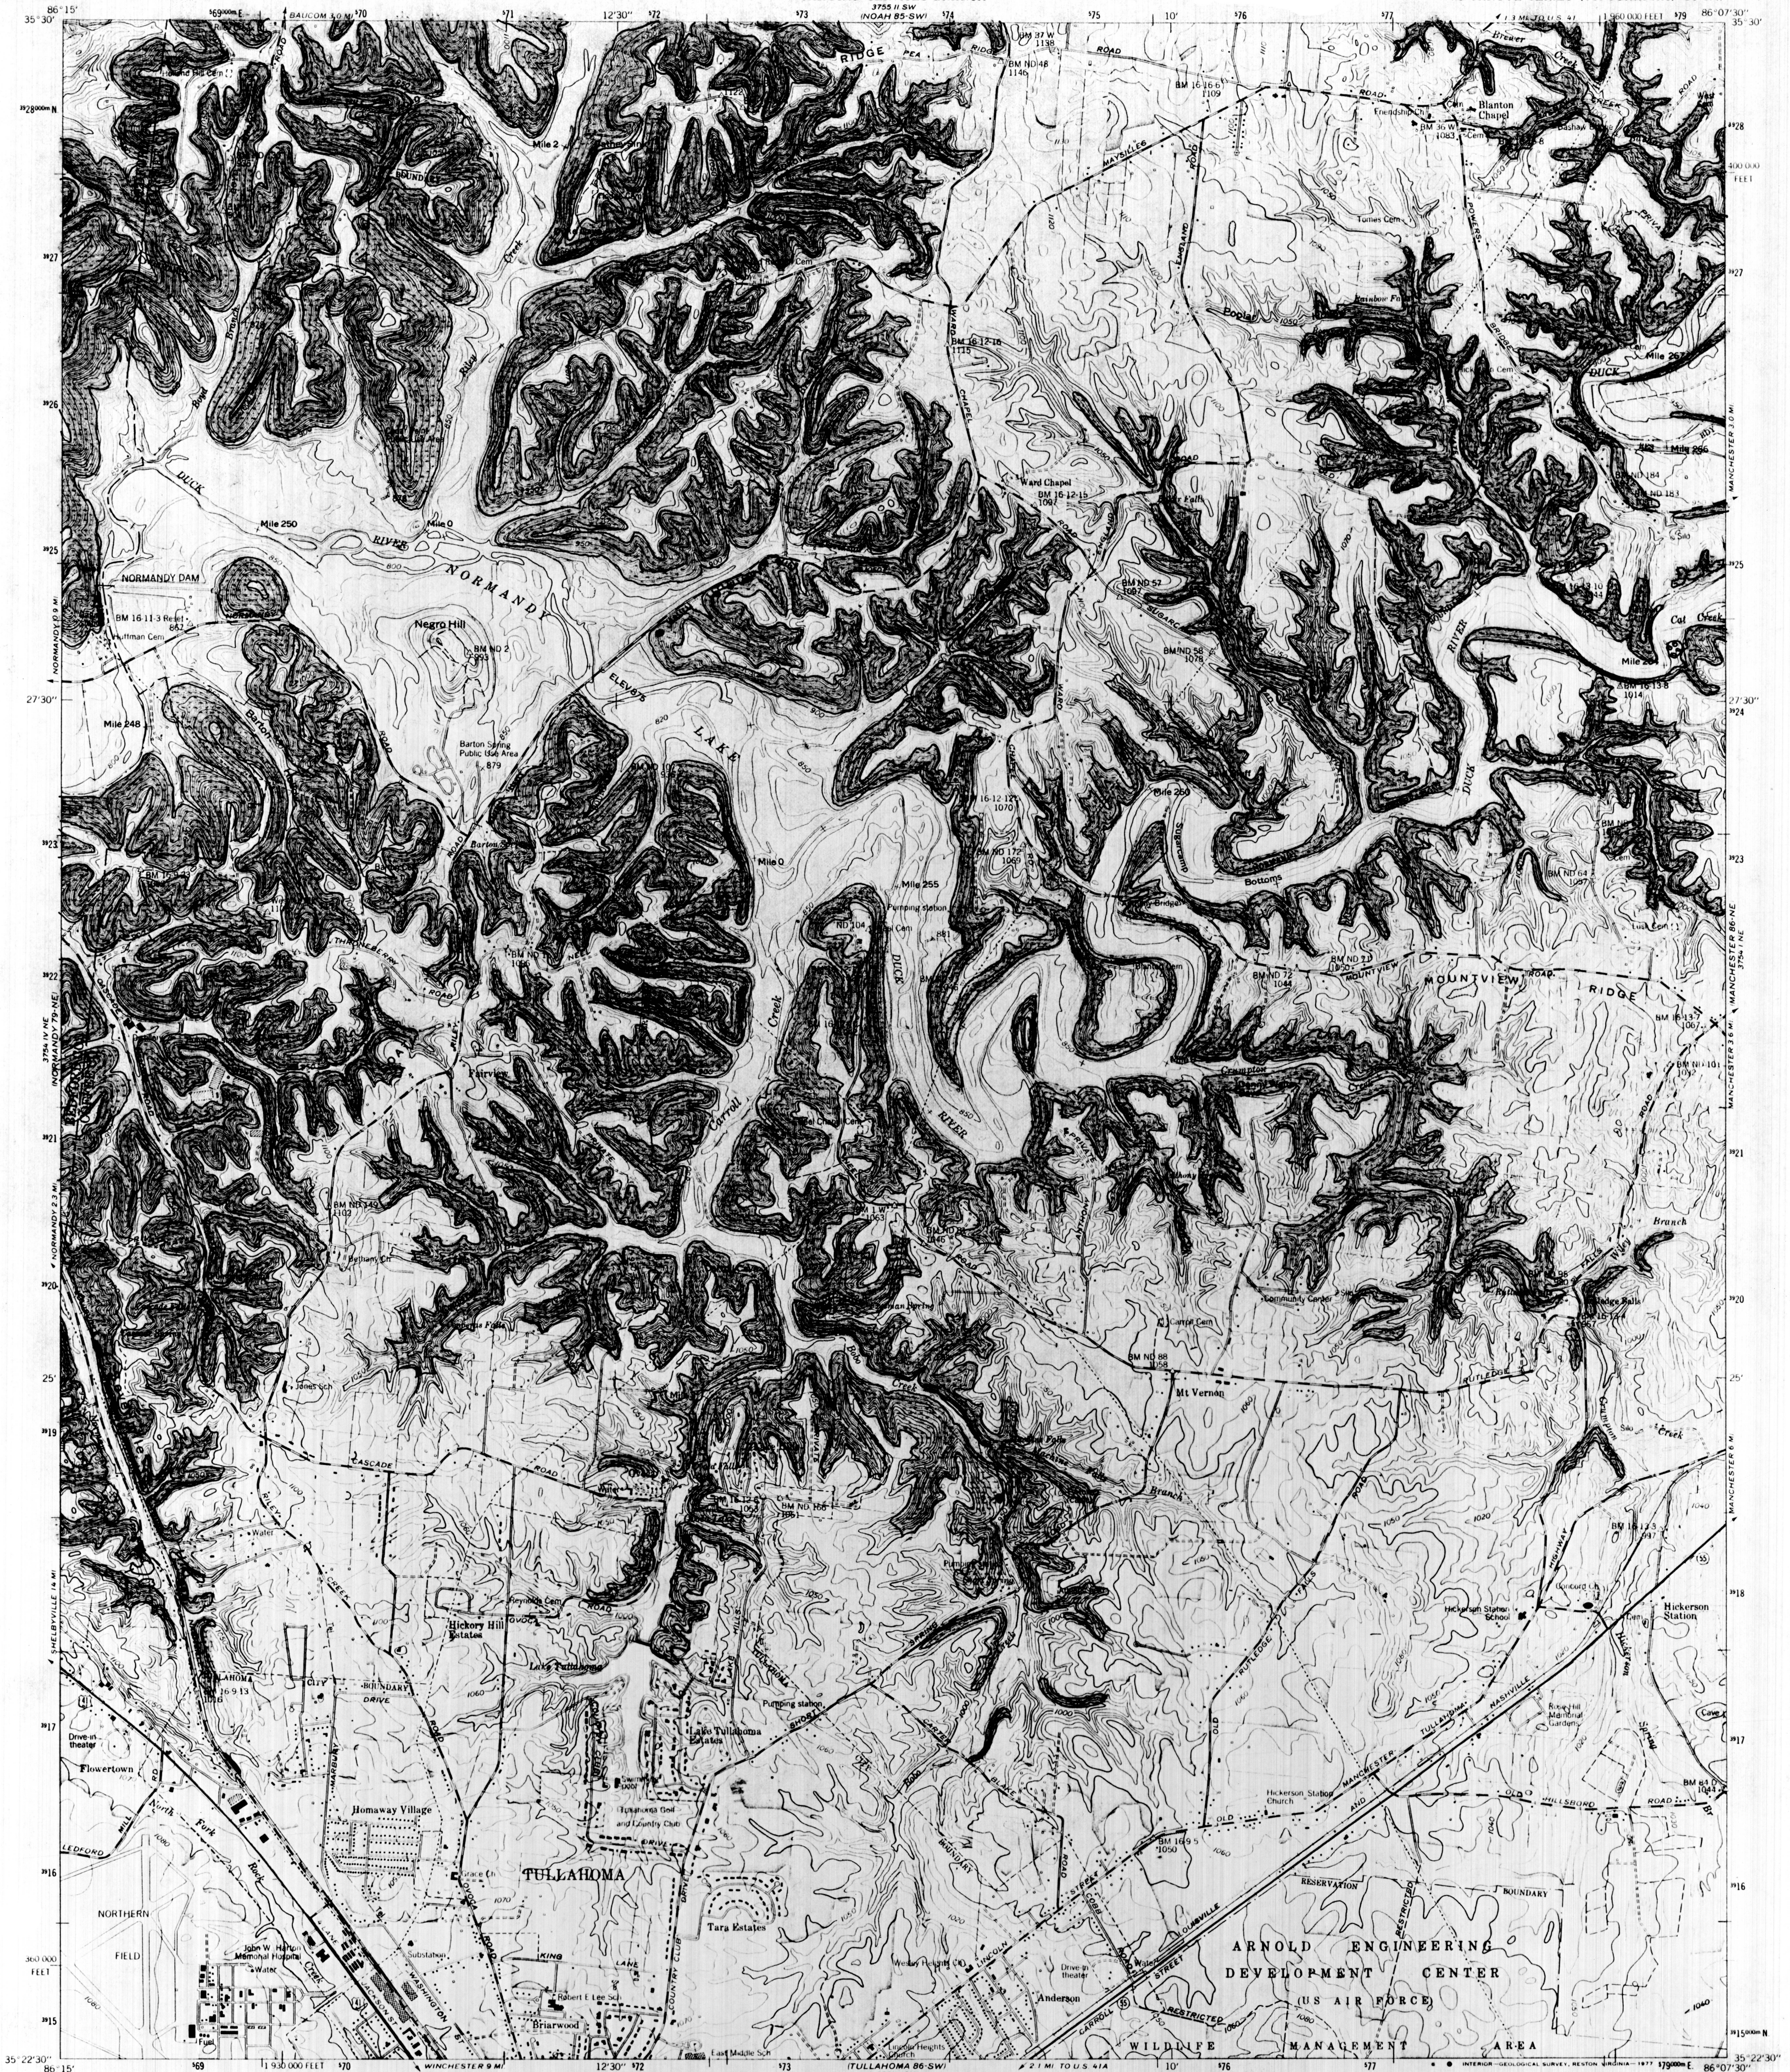
NORMANDY LAKE, TENN.
N3522 S-W8607 S-7.5
1976

Landslides and related features interpreted
from aerial photographs:
1:40,000 (black and white) 1979
1:58,000 (color infrared) 1980

Photointerpretation and field check 1980-1981
This report is preliminary and has not
been reviewed for conformity with U.S.
Geological Survey editorial standards.

ACTIVE OR RECENTLY ACTIVE LANDSLIDE
Complex landslide composed of earthflow, debris
slide, earth and rock slump. Identified from
historical records, and from scars, debris and
other field evidence. Ground extremely unstable;
sliding accelerated by excavation, loading and
changes in drainage conditions. May include
areas with several active slides too small to
be shown separately. Questioned where doubtful.

OLD LANDSLIDE
Area of extensive hummocky ground caused by
earthflow and earth and rock slump. Lacks
clear evidence of active sliding. Relatively
stable in natural, undisturbed state,
generally not affected by small structures properly
sited in areas away from the edge of the toe;
can be reactivated by extensive, rapid exca-
vation, loading, and changes in ground water and
surface water conditions. Area of old landslide
probably includes recent ones not identified
from field evidence or otherwise documented.
Upslope boundary of landslide generally defined
by modified scarp, but downslope (toe) may be
gradational and not well defined. Questioned
where doubtful.

COMBINATION LANDSLIDE
Area of recent and old slides in which
individual slides are not identified.

COLLUVIAL SLOPE
Valley wall along major streams with slope as
steep as 40° (85%); stony, clayey silt soil up
to 50 ft. (15 m) thick; commonly buttressed by
a terrace or bench at the toe of the slope; very
susceptible to sliding by cutting of toe area,
removal of terrace or bench, and overloading;
slide commonly activated without apparent cause.

COLLUVIAL SLOPES WITH LANDSLIDES
Landslides too small or obscure to map
individually.

**AREAS SUSCEPTIBLE TO DEBRIS FLOWS AND DEBRIS
AVALANCHES**
Primarily shallow, narrow ravines and chutes with
accumulation of stony colluvium generally 10 ft.
(3 m) or less in thickness; susceptible to rapid
movement during intense rainfall. Most ravines
and chutes designated show evidence of former
debris flows and avalanches.

AREAS SUSCEPTIBLE TO ROCKFALL
Steep, locally vertical, natural and man-made
slopes and cliffs, 15 ft. (4.5 m) or more high;
formed dominantly of sandstone, limestone, sandy
shale, mudstone and claystone. Interbedded mud-
stone, claystone and shale weather rapidly leaving
sandstone and limestone rock faces unsupported.

SOIL AND ROCK SUSCEPTIBLE TO LANDSLIDING
Soil and rock similar to that involved in land-
slides elsewhere in map area; primarily areas
underlain by claystone, mudstone and shale
associated with other rock types. Rock weathers
rapidly on exposure forming clayey soil highly
susceptible to sliding. Includes coves (U-shaped,
shallow valleys) containing thick layers of clayey
soil that are very susceptible to sliding where
excavation breaks continuity of slope and where
overloaded by artificial fill.

AREAS LEAST PRONE TO LANDSLIDES
Map areas in which no patterns or symbols are shown;
primarily valley floors, ridge tops and broad
benches; modification by excavation and fill may
lead to local landslides.

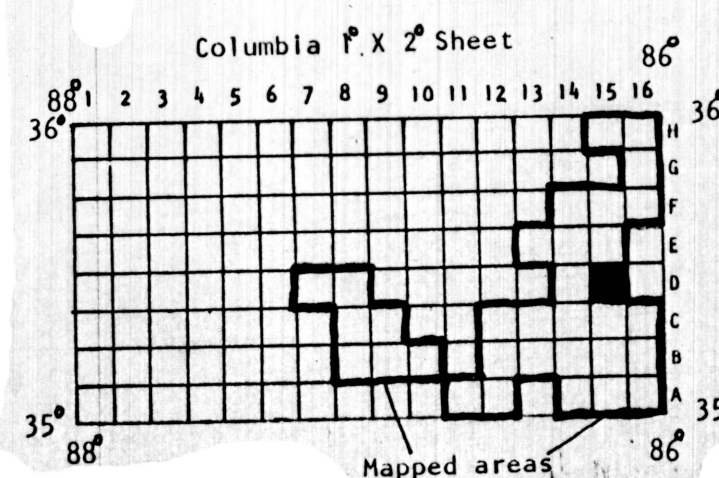
The first five digits of the open file number designate the
specific 1:250,000 scale map sheet of which this quadrangle
is a part. The last two digits designate the position of the
quadrangle in a subdivision of the 1:250,000 scale map based
on rows and tiers shown in the diagram to the right. The
location of this quadrangle is shown by the black square.
